FARMINGTON RIVER BASIN
HARTLAND, CONNECTICUT

**GOODWIN DAM
CT. 00541**

**PHASE I INSPECTION REPORT
NATIONAL DAM INSPECTION PROGRAM**

SEPTEMBER 1978

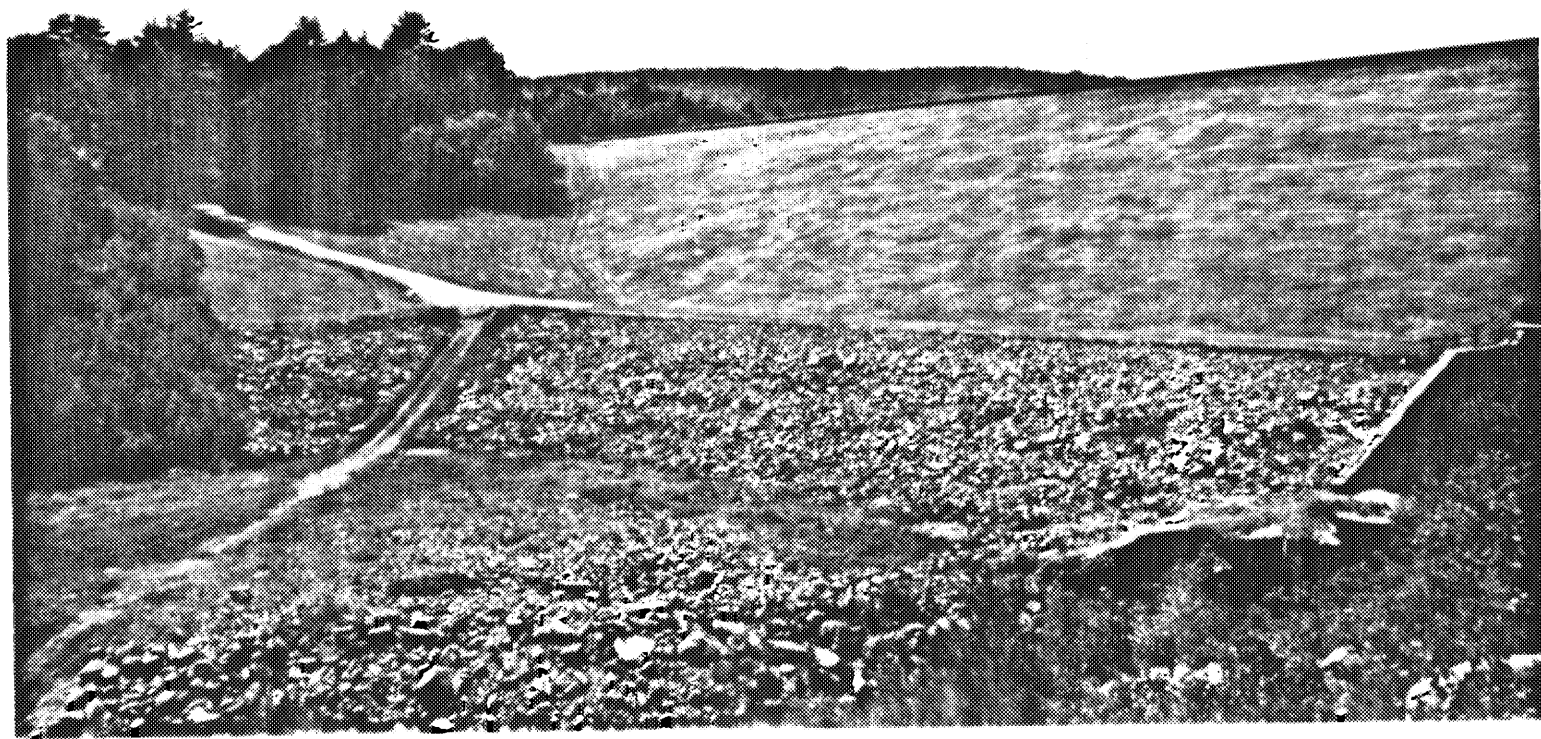
OVERVIEW PHOTO - GOODWIN DAM (HOGBACK)

The overview photo shows that the grass of the embankment is well maintained and free of any irregularities or bulges. In the area of the gate house, a parapet wall settlement of 4 to 5 inches was observed and appears to be normal for this location, however, there appears to be an increase from the Metropolitan District inspection results of 1973 when the settlements were 1 to 3 inches (Appendix B, Page B-1, Reference 6).

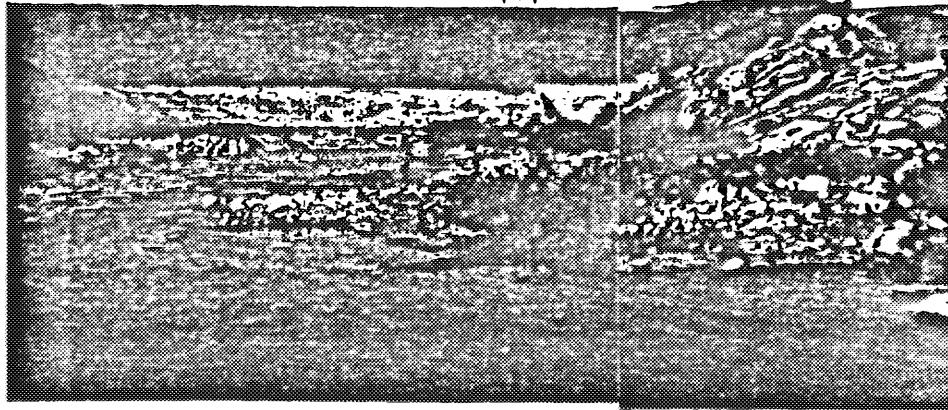
- 12) Is planting and/or debris etc. a fire hazard? No
- 13) Do plantings obscure toe of dam and other points where monitoring inspection is necessary? No, exceptionally clear - See Picture #1

#1. Showing good conditions on downstream face and toe of slope.

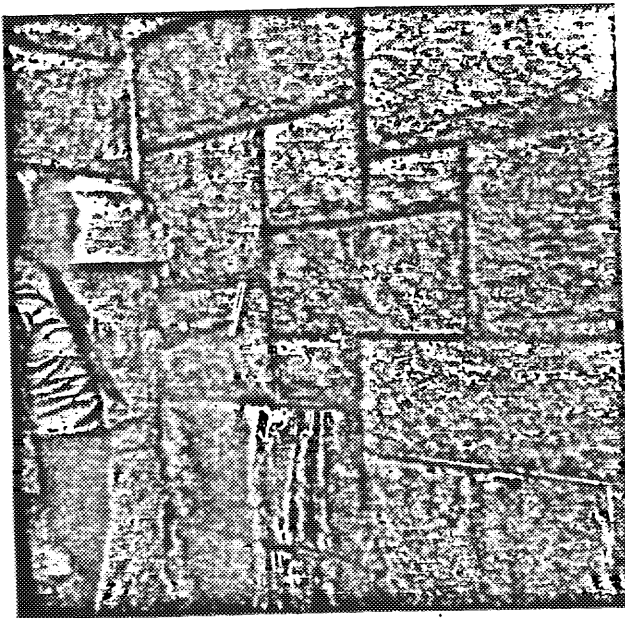
1. Movements of the stone parapet walls at the junction of the gate house walls. The lateral movements were four inches (west end) and six inches (east end). The vertical settlements measured five inches and four inches, respectively. According to the inspection of October 10, 1973, the measurements were three inches and one inch, respectively.
2. Wetting, seepage and leaching of concrete along the horizontal construction joints of the interior walls of the gate house.
3. Considerable seepage from contraction joints and the vertical crack of the diversion channel in the zone near the gate house (the crack was formed

#2. Parapet wall settlement at west side of upper Gate House.

2. Establish permanent monitoring of the behavior of the dam for the following observations:
 - (a). Movements of the parapet walls relative to the gate house. The frequency of the readings should be yearly.
 - (b). Seepage discharges through the dam in the zone of the diversion tunnel. The discharges should be measured in the two horizontal drains located at the outlet of the tunnel. The frequency of these readings is suggested monthly.
 - (c). Seepage discharges through the contraction joints and the vertical crack in the diversion tunnel from an area located near the downstream wall of the gate house. The frequency of these readings is suggested monthly.
 - (d). Temperature of seepage water so that additional information about the behavior of the structure can be formulated. The frequency of readings should be monthly.

- a. Alternatives - Not applicable.
- b. O & M Maintenance and Procedures -
 1. Movement markers for monitoring of movements of the parapet walls relative to the gate house should be installed.
 2. Arrangements for metering of seepage discharges through the cracks, contraction joints and horizontal drains into concrete of the diversion tunnel should be commenced.
 3. Seepage cracks and joints into concrete of diversion tunnel should be repaired.
 4. Round-the-clock surveillance because of the location of the dam upstream of a populated area should be provided if spillway discharge from Colebrook Dam is anticipated or occurring. In addition, the owner should develop a formal system for warning downstream residents in case of an emergency.

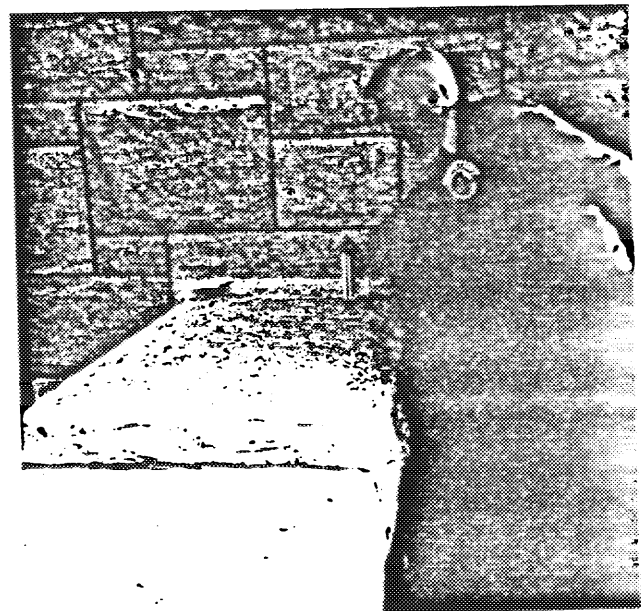
#3. Parapet wall settling has caused some minor joint separation on upstream side adjacent to Upper Gate House.

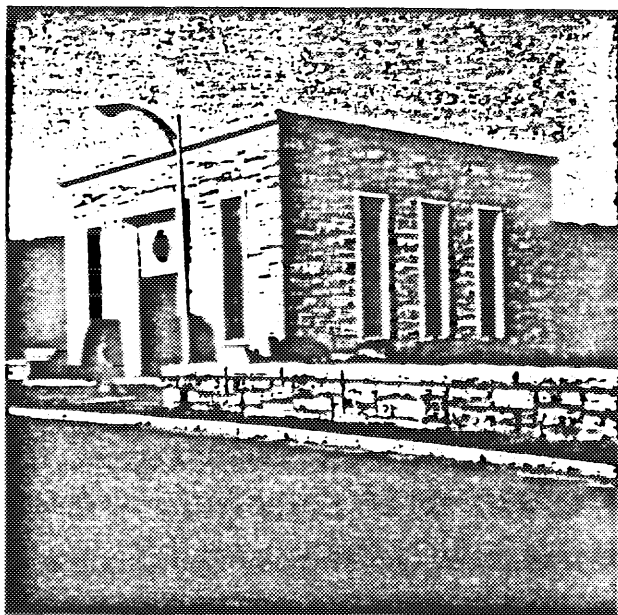
1) Exterior: walls Excellent - See Pictures #4 and #5.
windows Good - 2 lights middle window west side broken.
doors Gen. Good - slight weathering problem.
roof Excellent - new roof in 1972.

#4. Upper Gate House is in excellent condition.

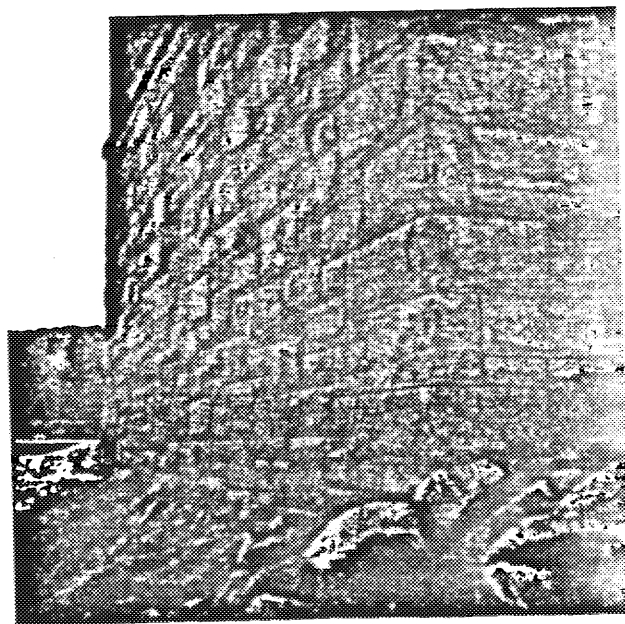
#5. Upstream face of Upper Gate House shows no ice damage.

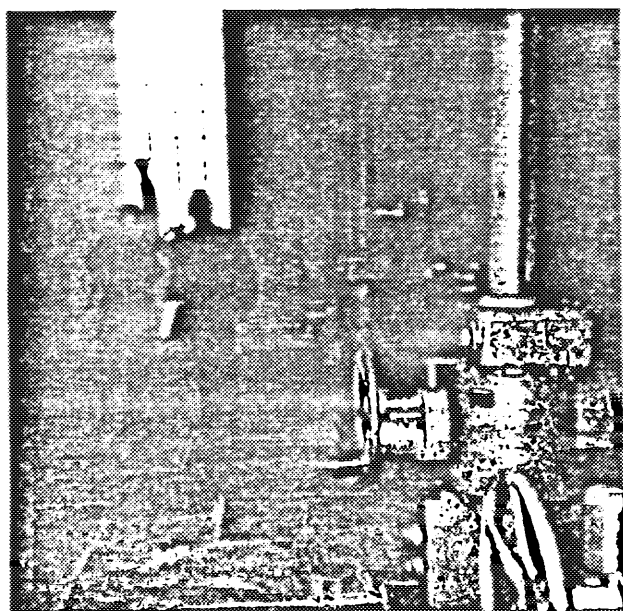
#6. Excellent conditions on Upper Gate House interior.

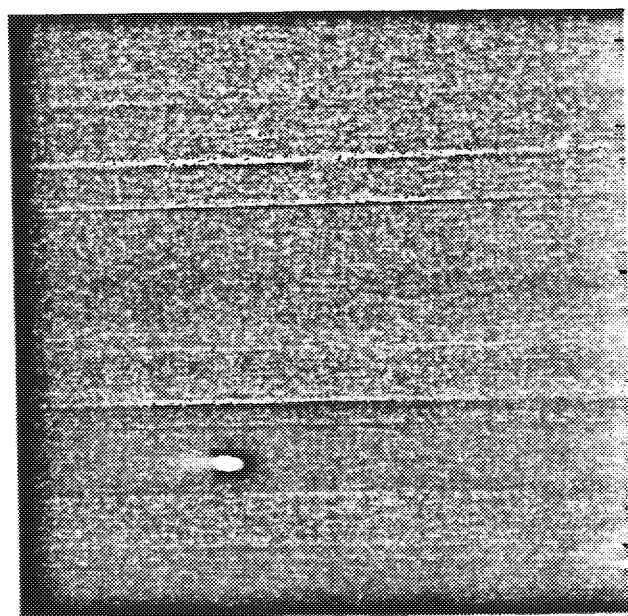
ceiling Good - Cracks in ceiling beams - See Picture #7

#7. Ceiling beams in Upper Gate House are cracked near center. Should continue to be monitored.

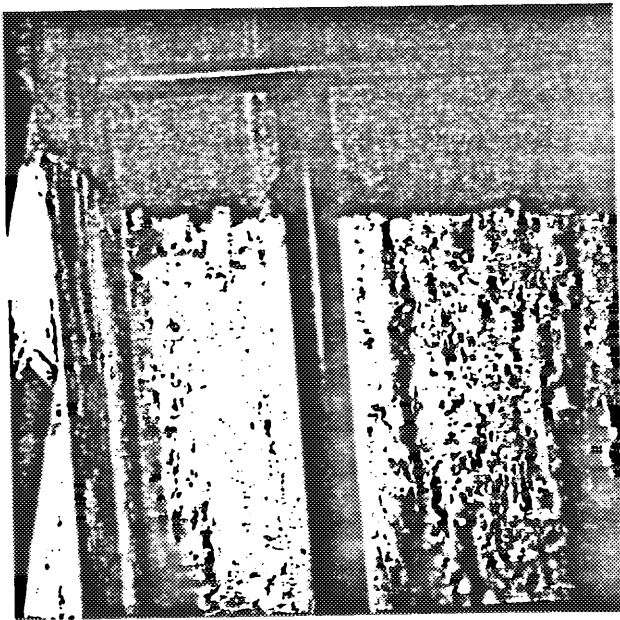
#8. Lime leaching at first joint below water line.

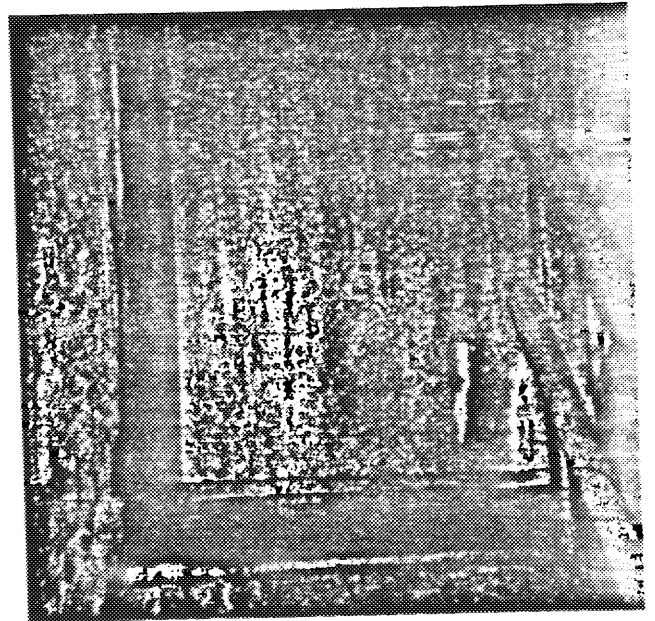
#9. Generally wet below water line.

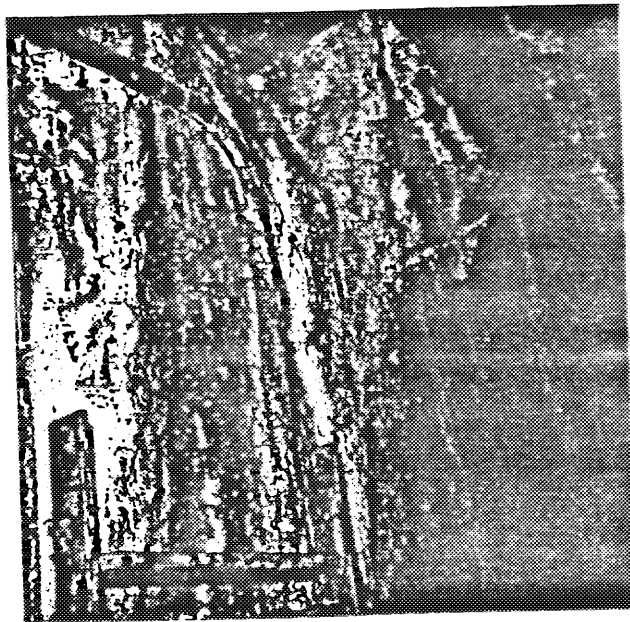
#10. Poor conditions in stream flow tunnel.

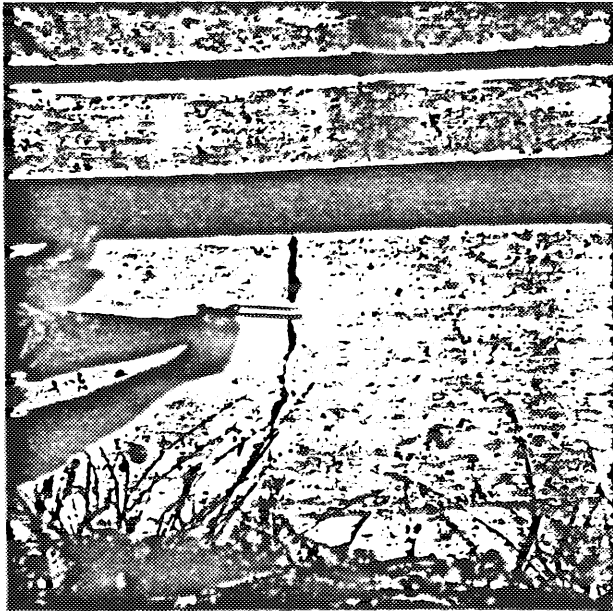
#11. South face at West end. Finger points to location of rollers.

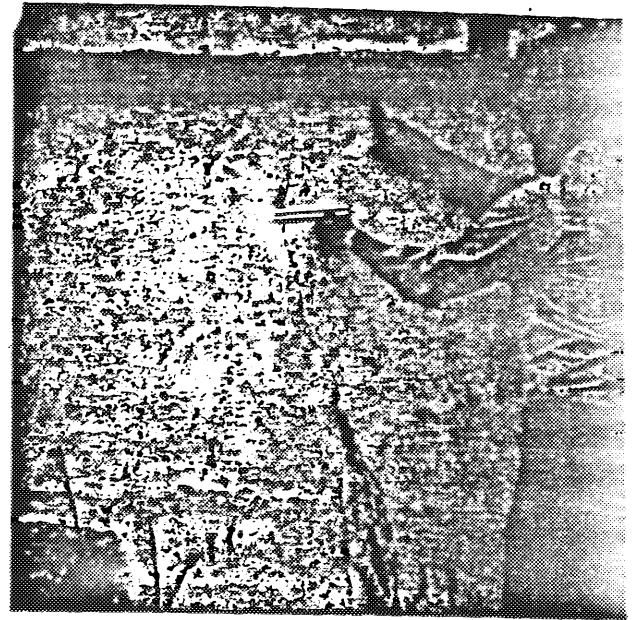
#12. North face at West end. Finger points to location of rollers.

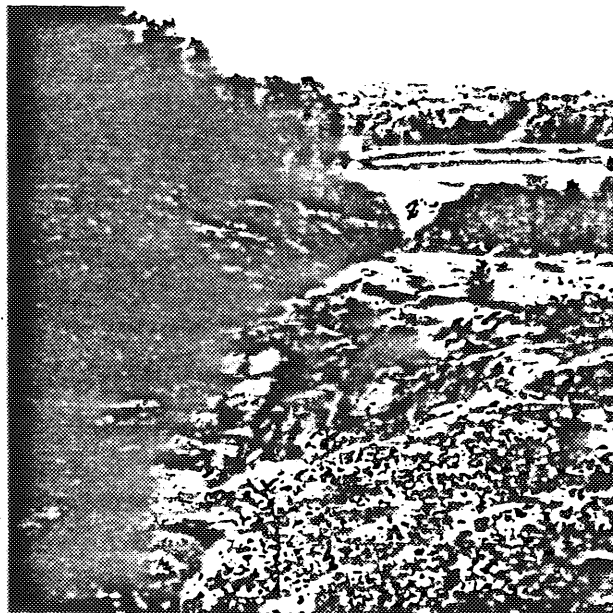
#13. Rock cut on east side of spillway channel is presently accessible from woods and is a potential hazard to casual wanderers.

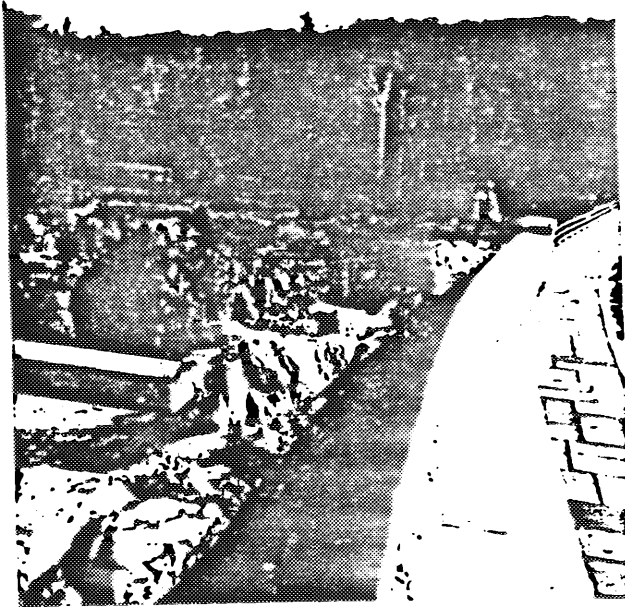
#14. There is presently no effective barrier to upstream west side of spillway channel.

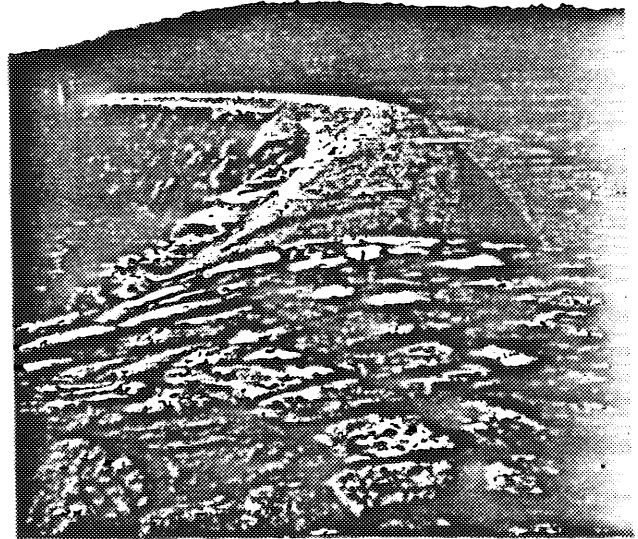
#15. This area is directly accessible from point indicated in picture #14.

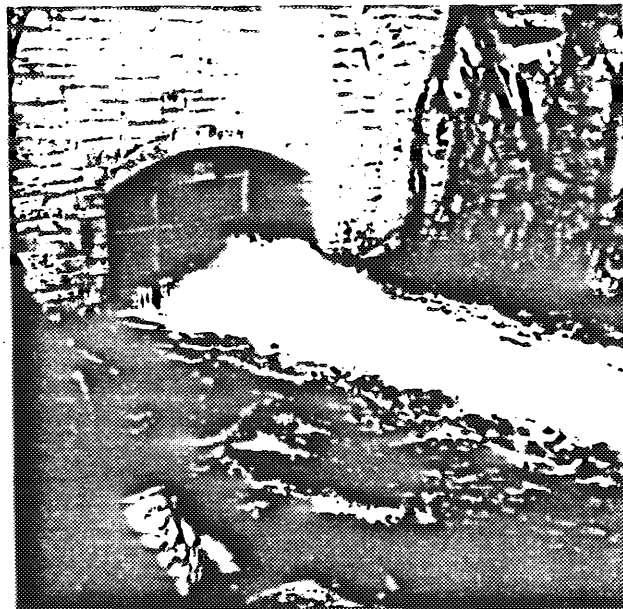
#16. Outlet of stream flow tunnel passing 230 cfs.

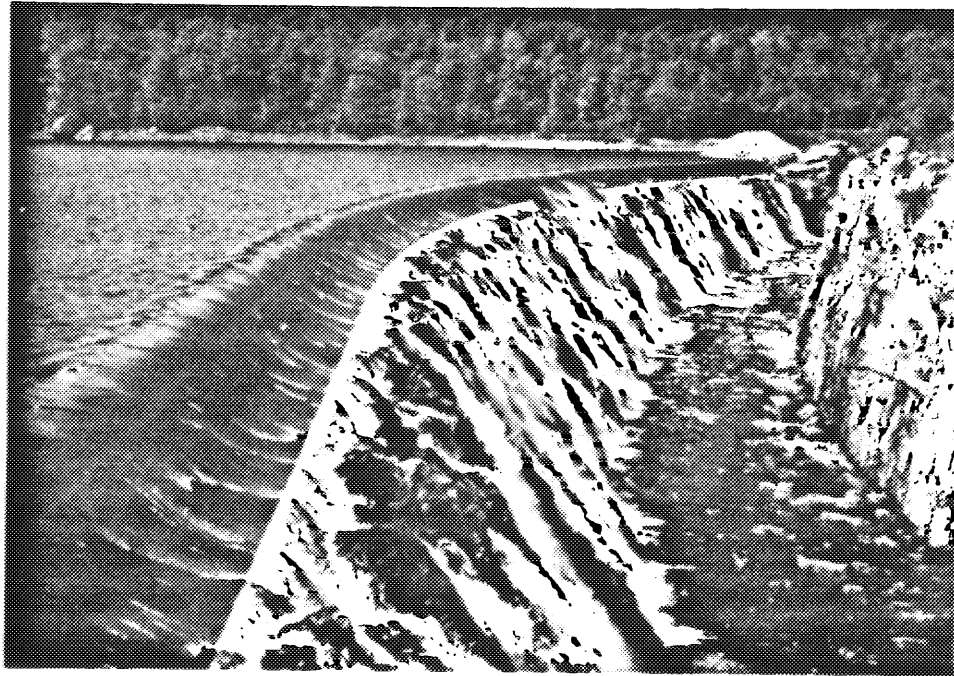
PHOTO 3
SPILLWAY WEIR

c. Appurtenant Structures - The spillway is a concrete weir on top of a ledge channel (Appendix C, Page IF-2) and is in good condition. The spillway channel condition is excellent and there are no evidences of loose rock or slippage of any ledge.

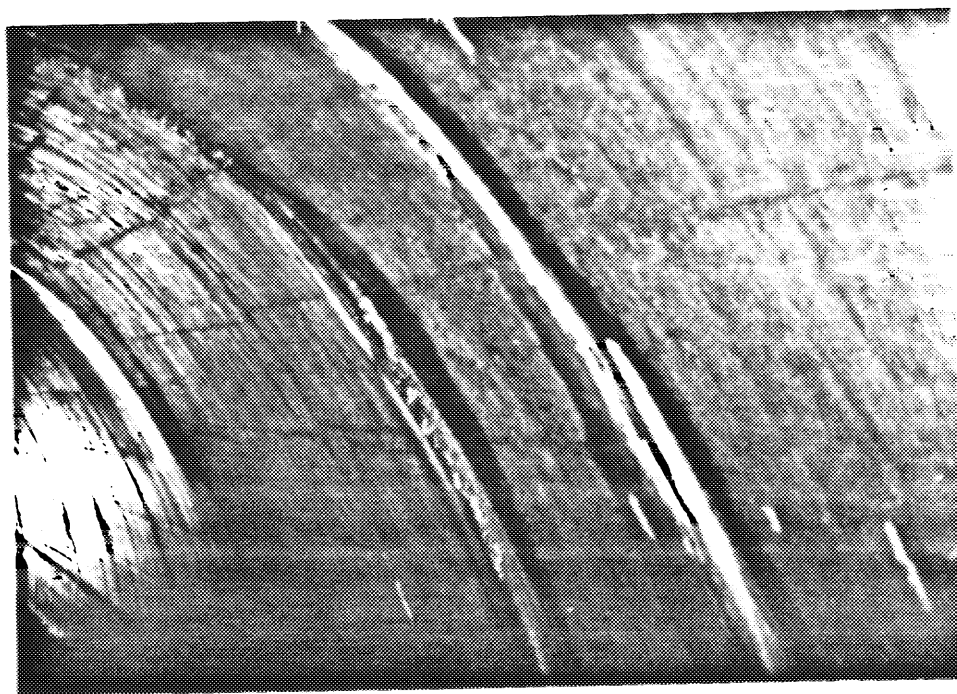
The inspection of the gate house and diversion tunnel showed that there is some minor leakage and leaching along the construction joints of the interior walls. At the time of the inspection, one, 24 inch diameter gate was partially open so minimum flow could be maintained. The resulting moisture in the tunnel was evident and at two construction joints and one vertical crack (Appendix C, Page II-4) flows were visible, approximately 4 to 6 gallons/minute from the joints and 2 gallons/minute from the crack. This seepage caused leaching of lime from the concrete.

PHOTO 8
DIVERSION TUNNEL - CONSTRUCTION JOINTS

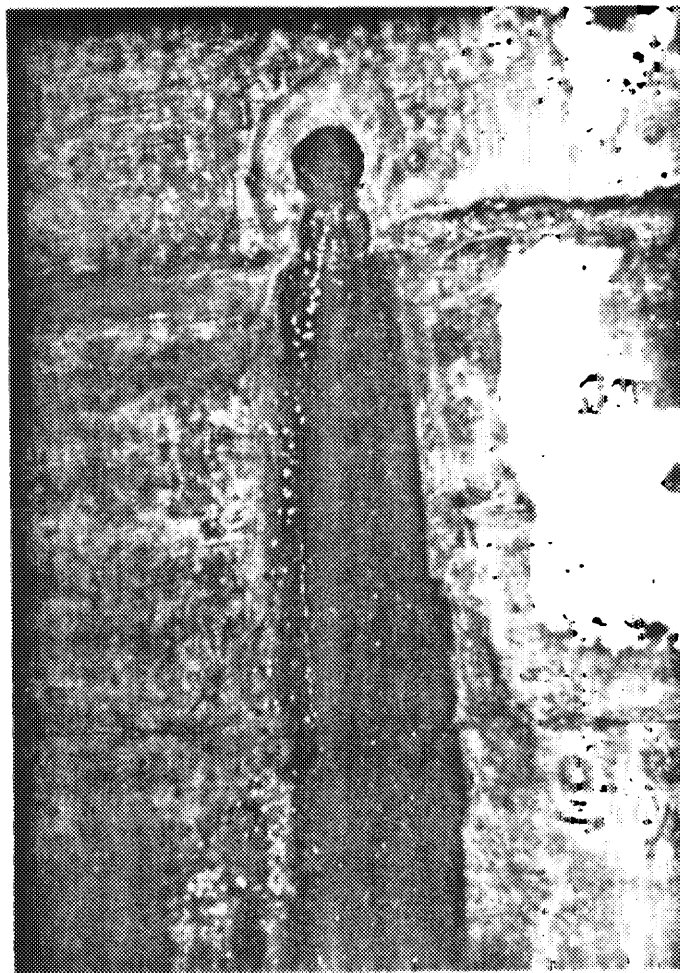
PHOTO 9

during the construction period. The total seepage discharge is approximately 6 to 7 gallons/minute. This seepage has evidence of leaching of lime from the concrete and rusting of reinforcement in concrete.

SEEPAGE OUTLET - END OF DIVERSION TUNNEL

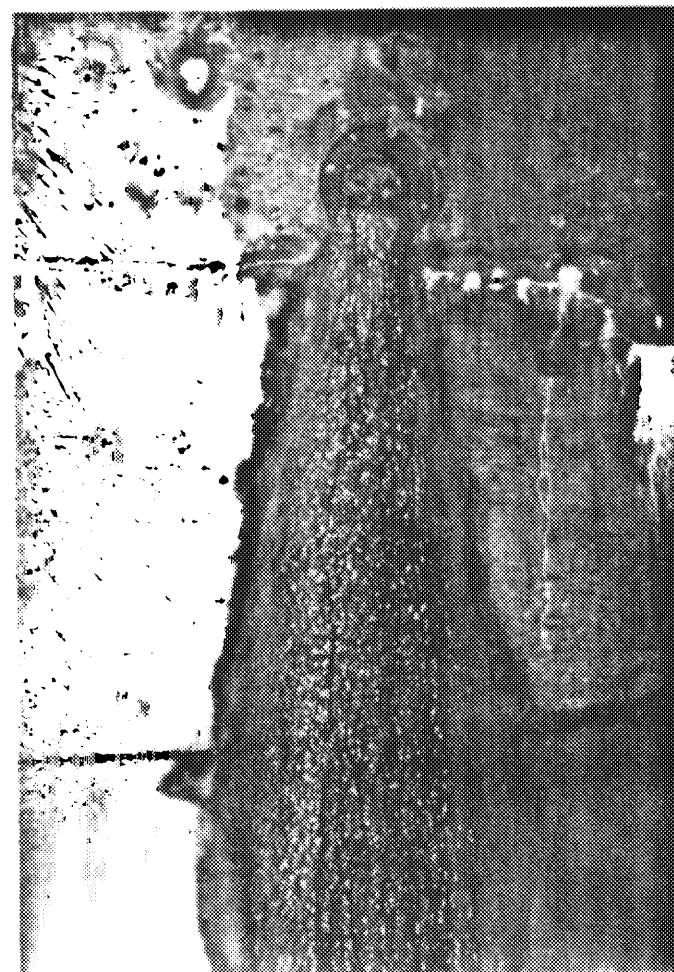
PHOTO 10

SEEPAGE OUTLET - END OF DIVERSION TUNNEL
